From: [Benjamin Krebs](#)
To: joseph.spadone@NSCorp.com
Subject: Railroad drainage and erosion in south Lexington area

Thank you for talking with me last week regarding some reoccurring drainage issues near the railroad and Derby Drive properties in Lexington. This is follow-up to our conversation and your request for additional information and possible recommendations. See attached picture summary of the issues. Please take a look and let me know if you would like to meet onsite to discuss further.

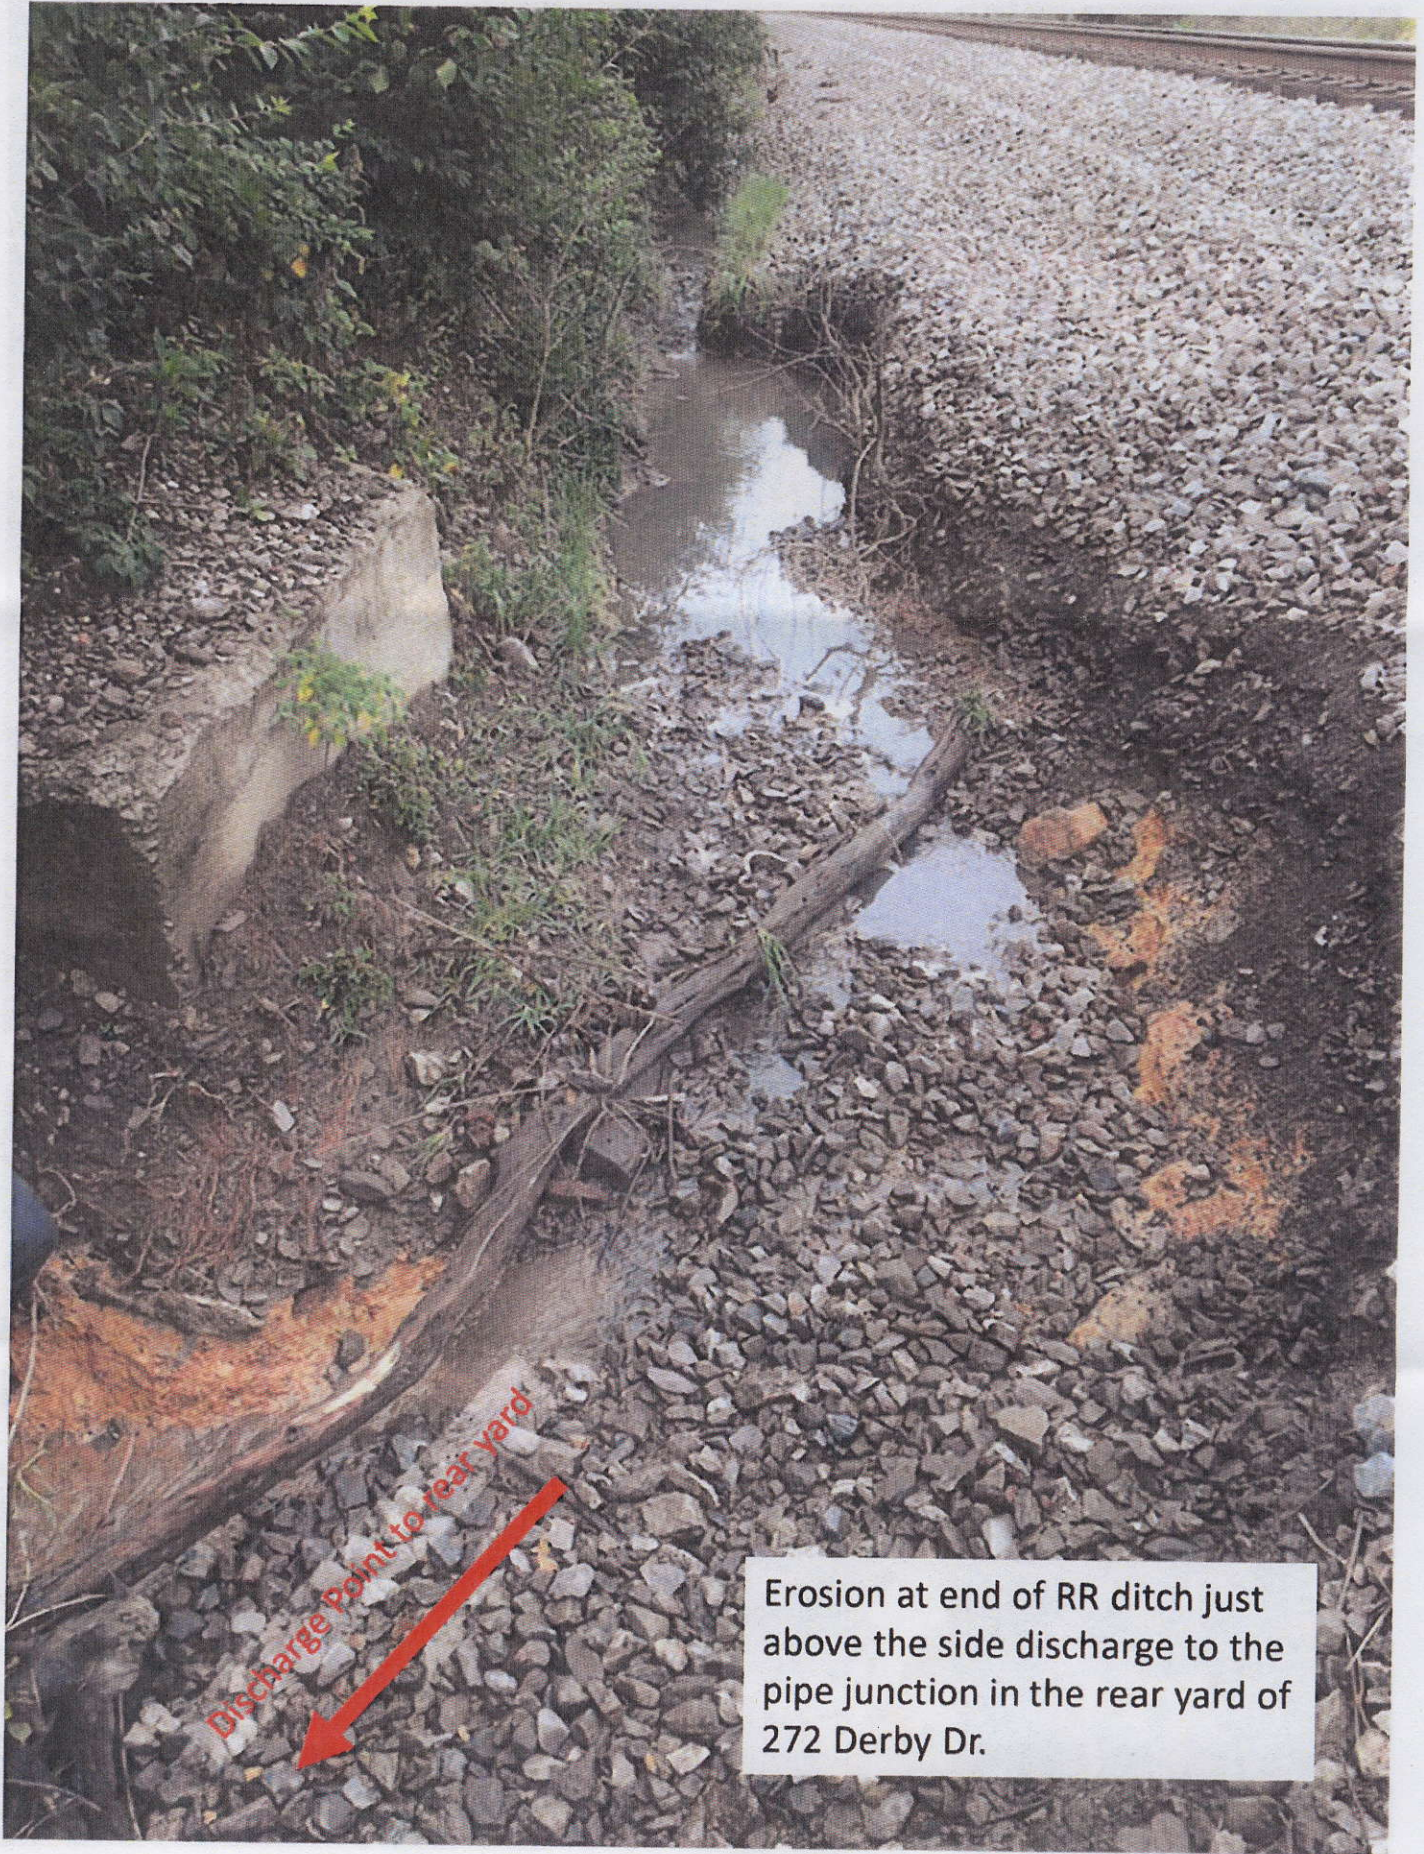
Discharge point to rear yard

Erosion at end of RR ditch just above the side discharge to the pipe junction in the rear yard of 272 Derby Dr.

September 2015 storm event deposits filled junction area.

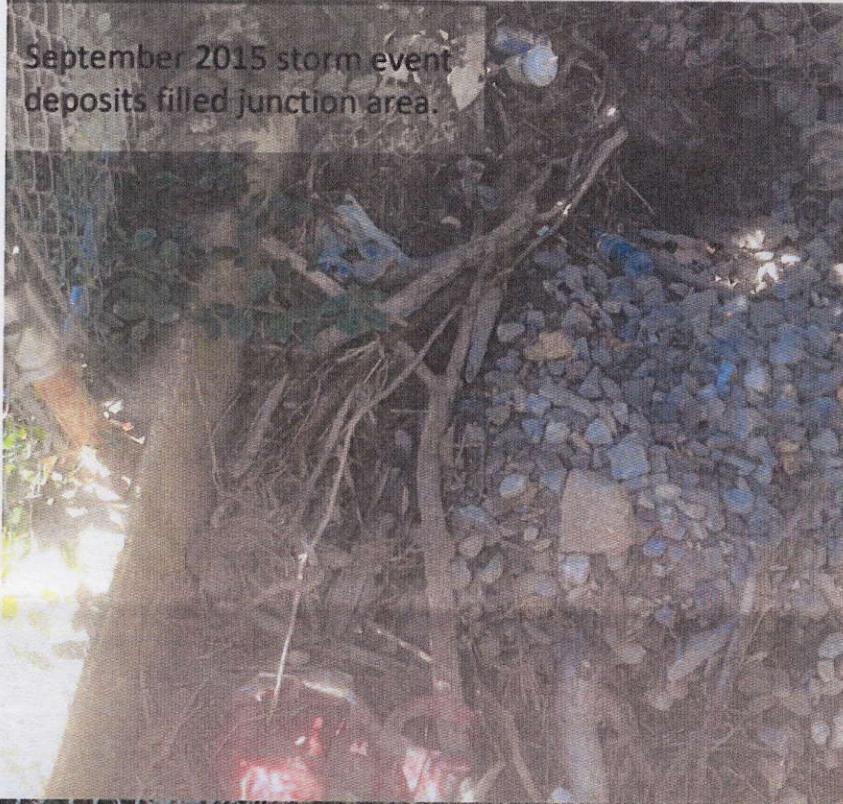
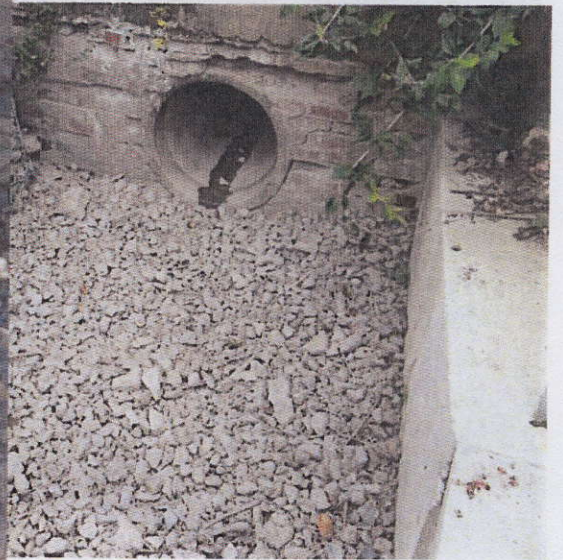
Cleanup after Sept. event.

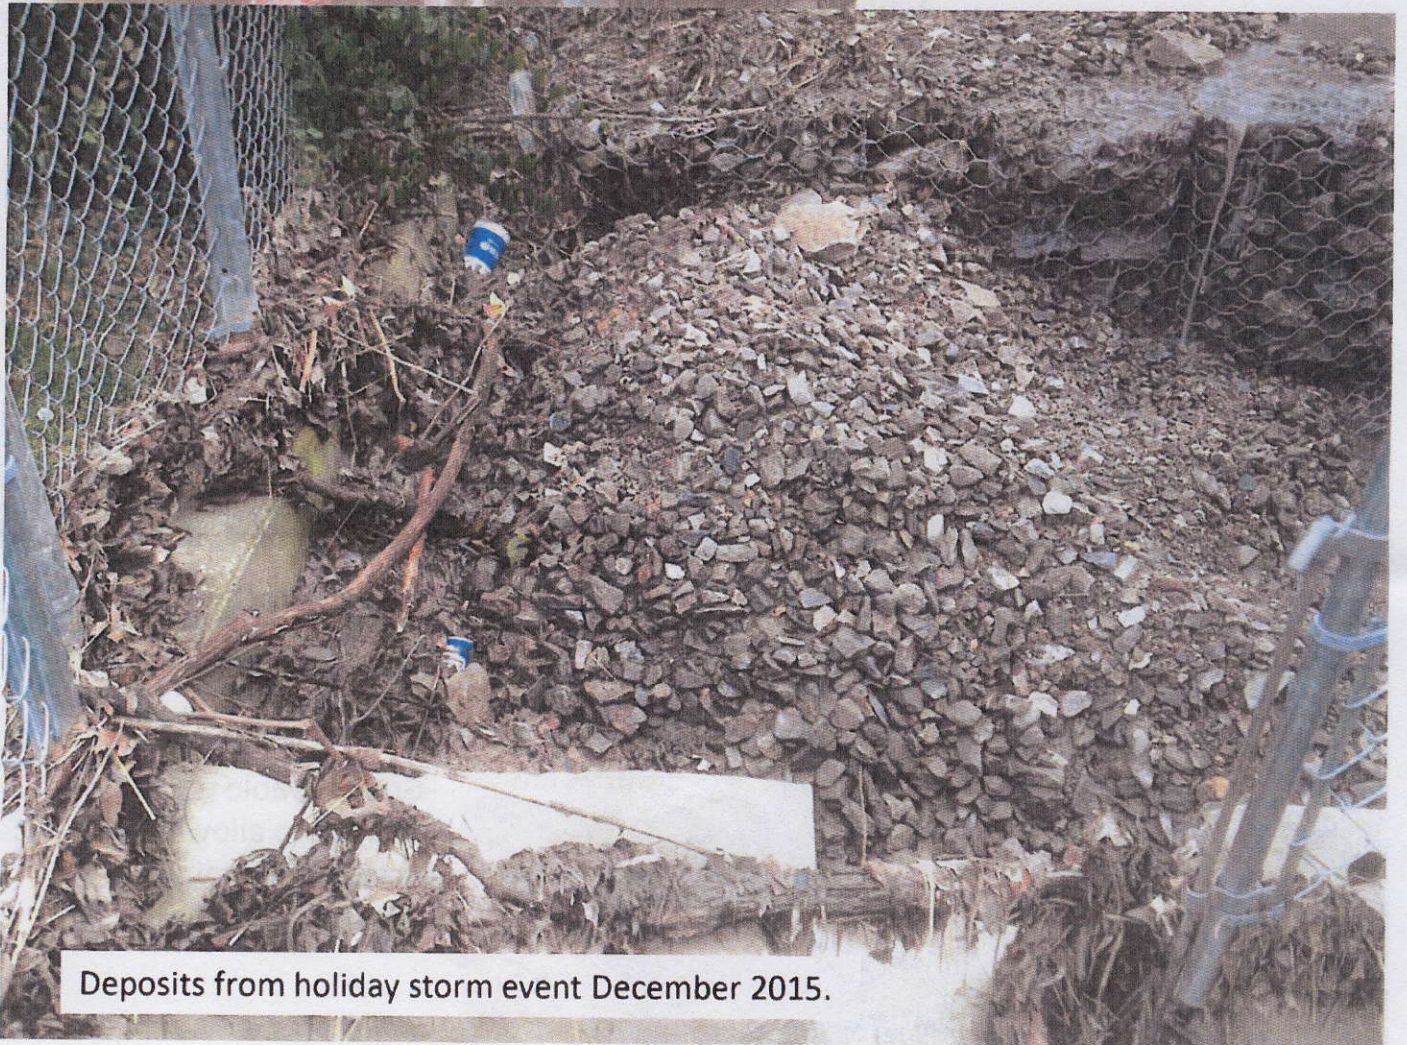
Deposits from holiday storm event December 2015.

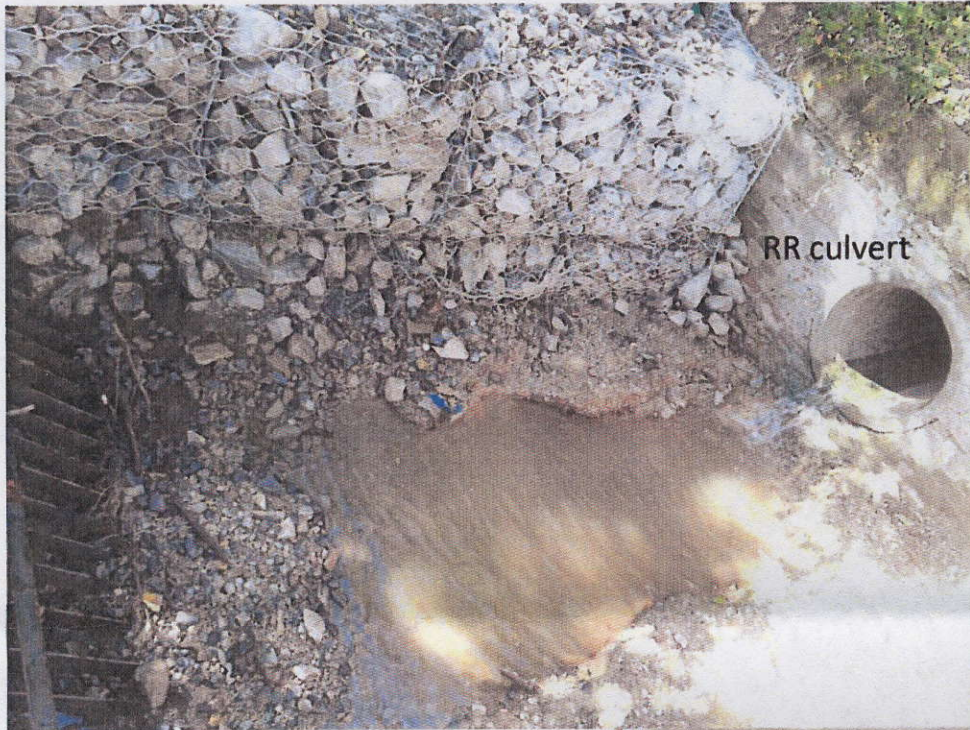
Improvements to pipe junction in August 2014 to aid maintenance and prevent pipe clogging.

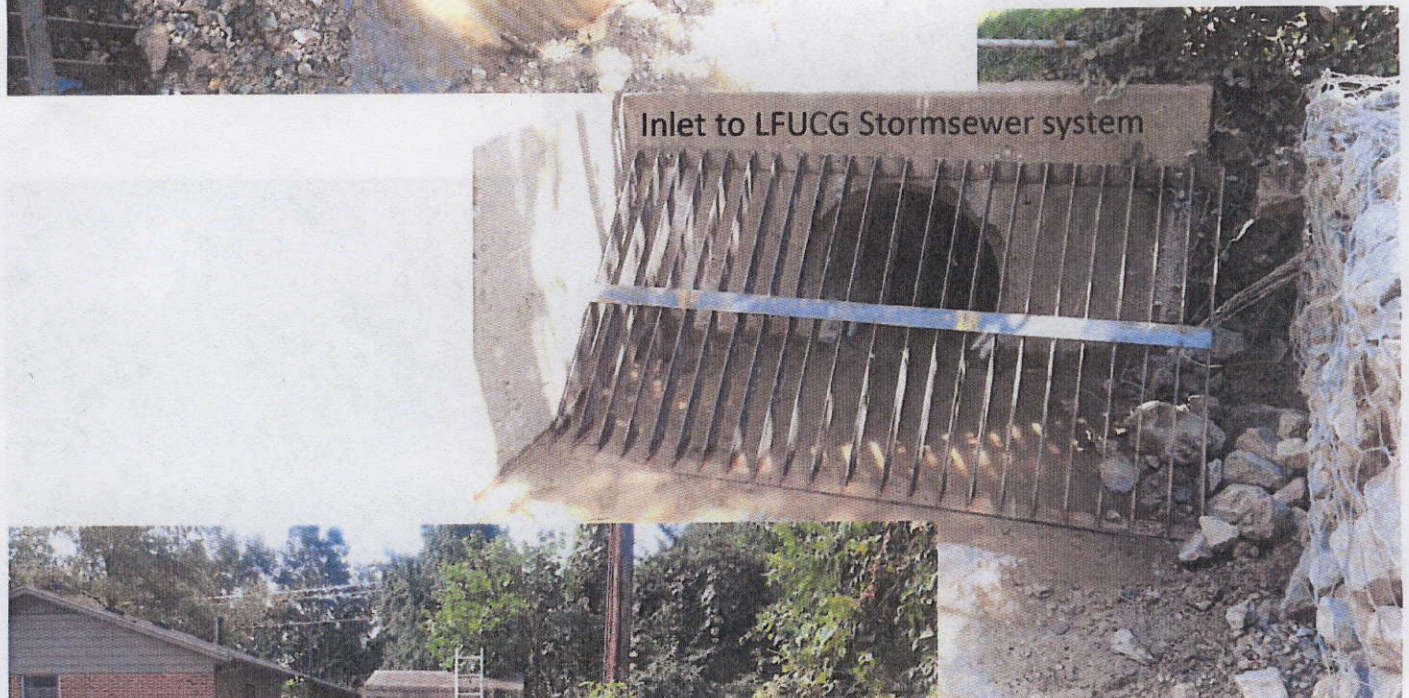
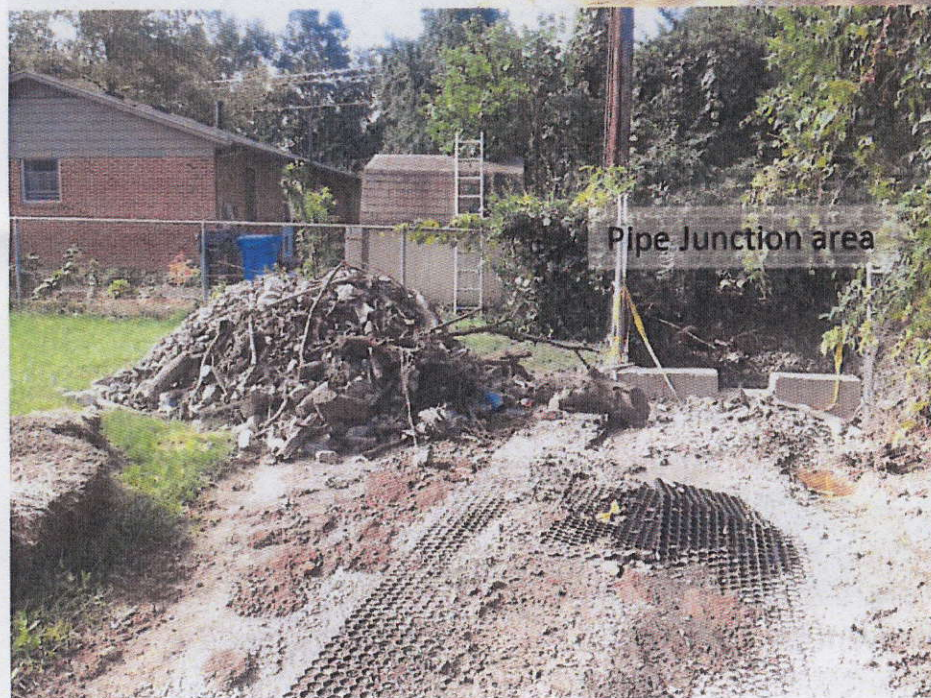
Debris (pile) removed from junction area after storm event August 10, 2014.

-Grid (drivable grass) was installed to allow equipment access with minimal damage to rear yard.
